# WHY BUILDINGS FALL DOWN

How Structures Fail

MATTHYS LEVY  
and  
MARIO SALVADORI

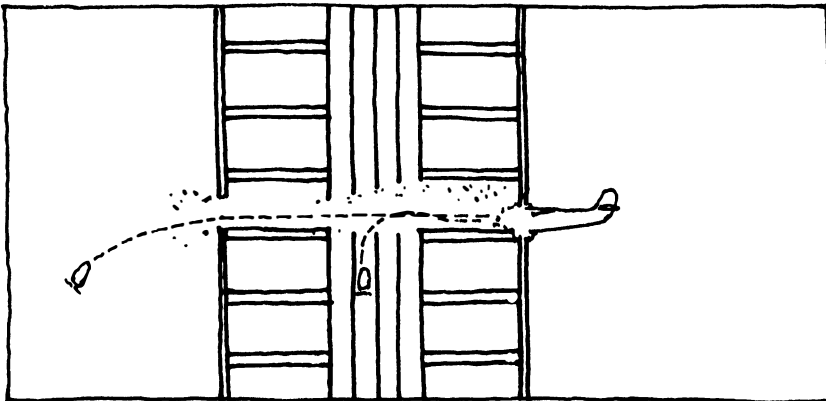
**2.3a B-25 Just before Impact**

**2.3b Impact and Path of Motors**

plane, the wheels were lowered moments before the plane struck the Empire State Building on the north face of the seventy-ninth floor, 913 ft. (278 m) above the ground, ripping a hole 18 ft. (5.5 m) wide and 20 ft. (6 m) high in the outer wall of the building (Fig. 2.2). The force of the impact sheared off the wings of the plane and propelled one of the two motors across the width of the building, through the opposite wall, and down through the twelfth-story roof of a building across Thirty-third Street, starting a destructive fire that demolished the studio of Henry Hering, a noted sculptor of the time (Fig. 2.3). The other motor and part of the landing gear crashed into an elevator shaft and fell all the way down to the

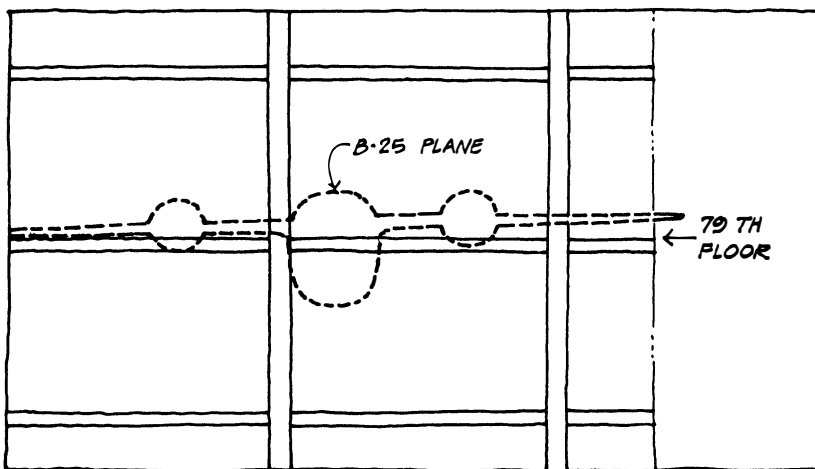
The center of impact aligned almost exactly with a column on the face of the tower. The right motor passed on one side of the column and the left motor on the opposite side (Fig. 2.4). The column itself was barely damaged, although a steel beam supporting

**2.4 B-25 Straddling Column**

the masonry wall struck by the right motor was torn out, and a second beam supporting the floor slab was bent back 18 in. (450 mm). The plane apparently struck the seventy-ninth floor dead-on, which explains the lack of damage to the column. Had the plane been just a bit higher or lower, it might have struck and bent the column, and then . . .

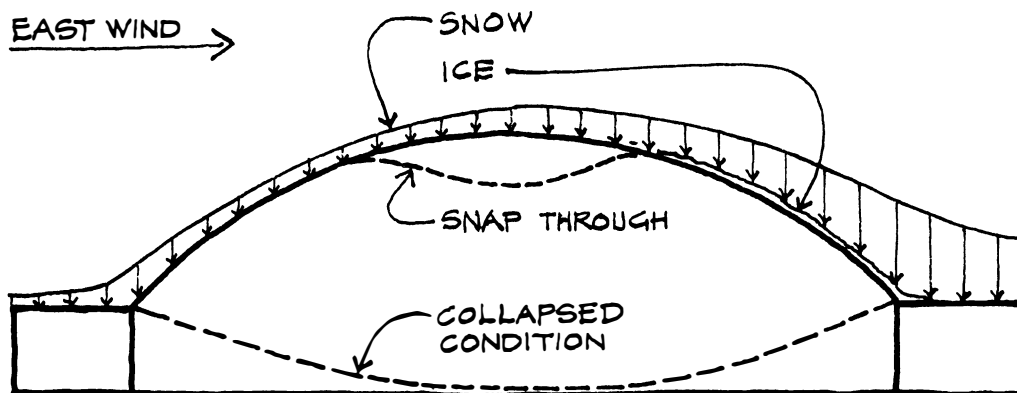
### 3.12 Stages of Collapse of C. W. Post Dome

Between 2:00 and 3:00 A.M. on Saturday, January 21, 1978, the center dome suddenly caved in under mounds of snow and ice. “It looks like a giant cracked eggshell,” commented Officer Stephen Chand of the Old Brookville Police Department (Fig. 3.12). Only four days earlier the 360 by 300 ft. (110 × 90 m) *flat* steel roof of the Hartford Civic Center Arena had collapsed under similar conditions (see p. 68), and one could have heard then the “amateur structuralists” comment on the traditional strength of the dome, the prototypical “form-resistant” structure: “They should have used a dome instead of a flat roof. It would have been stronger and cheaper!” But now...?

Three days later Nicholas W. Koziakin, a structural engineer with the renowned New York City office of Mueser, Rutledge, Johnston and DeSimone, inspected the site and, after numerous additional visits, presented on May 10 his thorough but qualitative report. He concluded mainly that the dome had been underdesigned by a simplified theory *inapplicable* to the reticulated dome structure, based on the assumption of *uniform* dead and live loads, and that the nonuniform snow blown on the dome by the wind, and the ice found under the snow the day of his first visit, may well have stressed the structure above allowable limits (Fig. 3.12). He advised that a more realistic model of the reticulated dome should be analyzed by a rigorous theory to check the design. Weidlinger Associates was entrusted with this analysis, and its report of May 1979 proved Mr. Koziakin's conclusions to have been entirely correct. As in some other structures, for the reticulated dome of the C. W. Post center "less was more." A snow load of only *one-fourth* the load required by the code but concentrated over a sector *one-third* of its surface was bound to collapse the dome! Indeed, that had been the story on the night of January 21, 1978, when a load of snow blown by an east wind had lodged onto the *leeward* side of the dome.

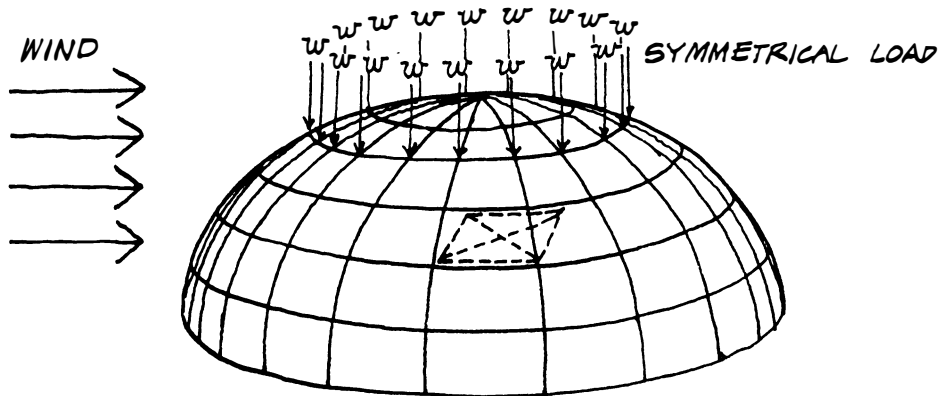
### 3.14 Skewing of Radial Ribs Caused by Wind

But perhaps the most dangerous consequence of using membrane theory in the design of shallow reticulated domes is that under symmetrical gravity loads its meshes *shrink* (slightly) on all four sides, *remaining square*, while under wind loads they become skewed (Fig. 3.14) and require diagonals to be stable. Finally, since most of the bars of the mesh are compressed, reticulated domes must be checked against the dangerous phenomenon of *instability in buckling as a whole*, which causes the dome to invert or *snap through*. (You may easily check instability in buckling by pushing down on a thin metal or plastic ruler that will bend out at right angles to its thin surface and lose all capacity to resist compression higher than a small push [p. 289, Fig. D4].) Rather unwisely the

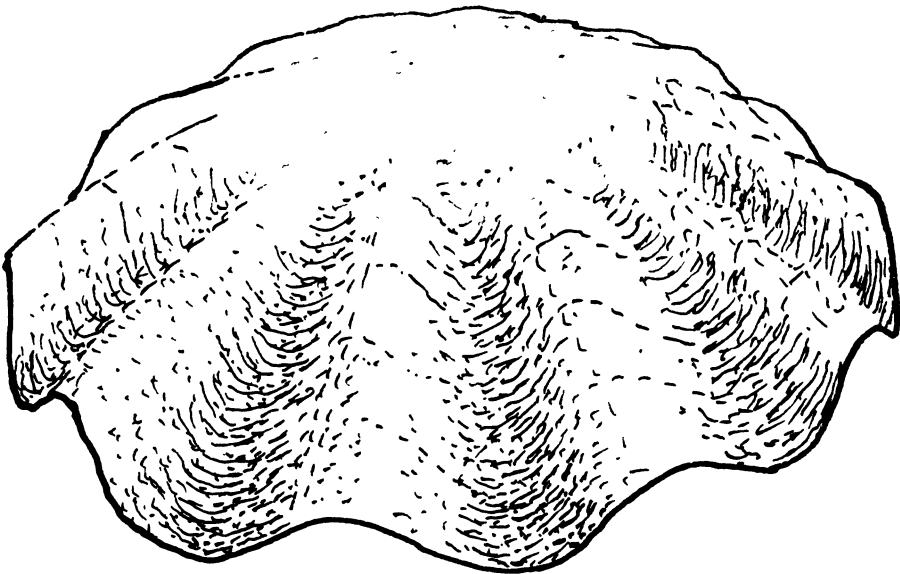
**3.17 Local Radial Buckling of a Dome**

Soare also remarked later that the bridle node connections had been entirely unable to prevent the relative sliding of the pipes meeting at the nodes. Rigid connections at the nodes of a reticulated dome are essential to maintain unchanged the geometry of the dome and to prevent bending deformations at the joints; no

light reticulated dome can be self-supporting without the satisfaction of these two conditions. Thus a probably minor saving in the cost of the connections may well have been a major contributory cause of the collapse.

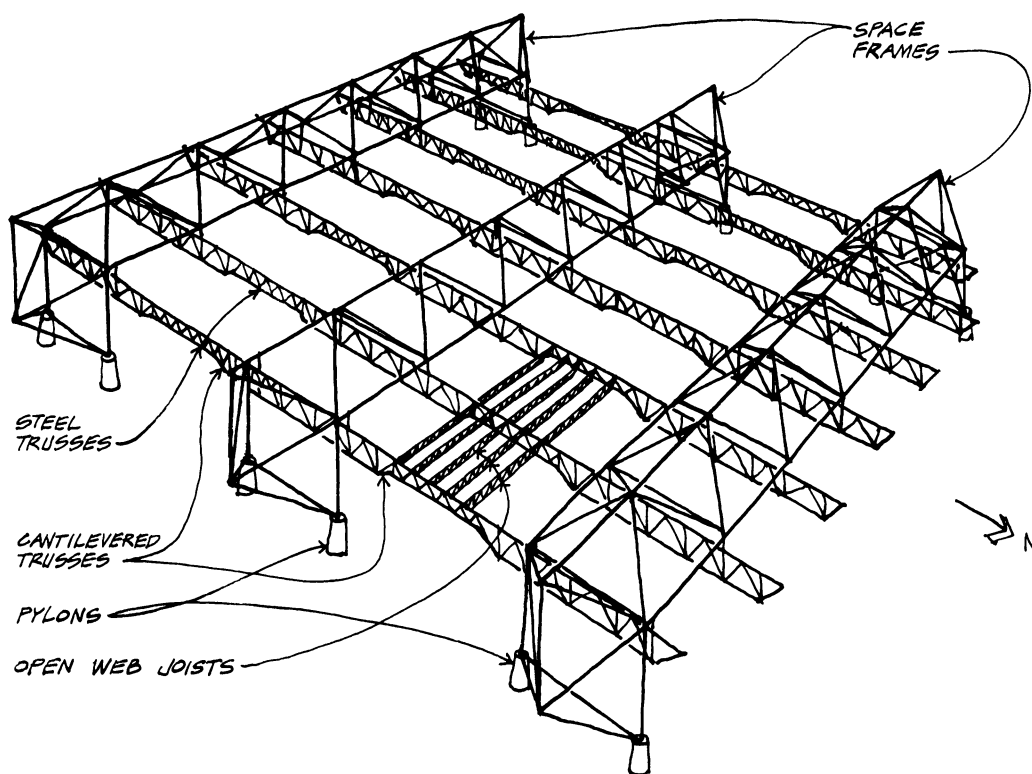
4.4 Diagrammatic Layout of Structure of the Kemper Arena

The basic structural elements supporting the loads of the roof itself and those acting on it, as well as the weight of the upper part of the walls of the arena, were three external space frames spaced at 153 ft. (46 m) in the north-south direction in the shape of rectangular portals, 360 ft. (108m) long in the east-west direction, and 81 ft. (24 m) high (Fig. 4.4). The horizontal element, or beam, of the portals consisted of a *space frame* of steel tubes with an equilateral

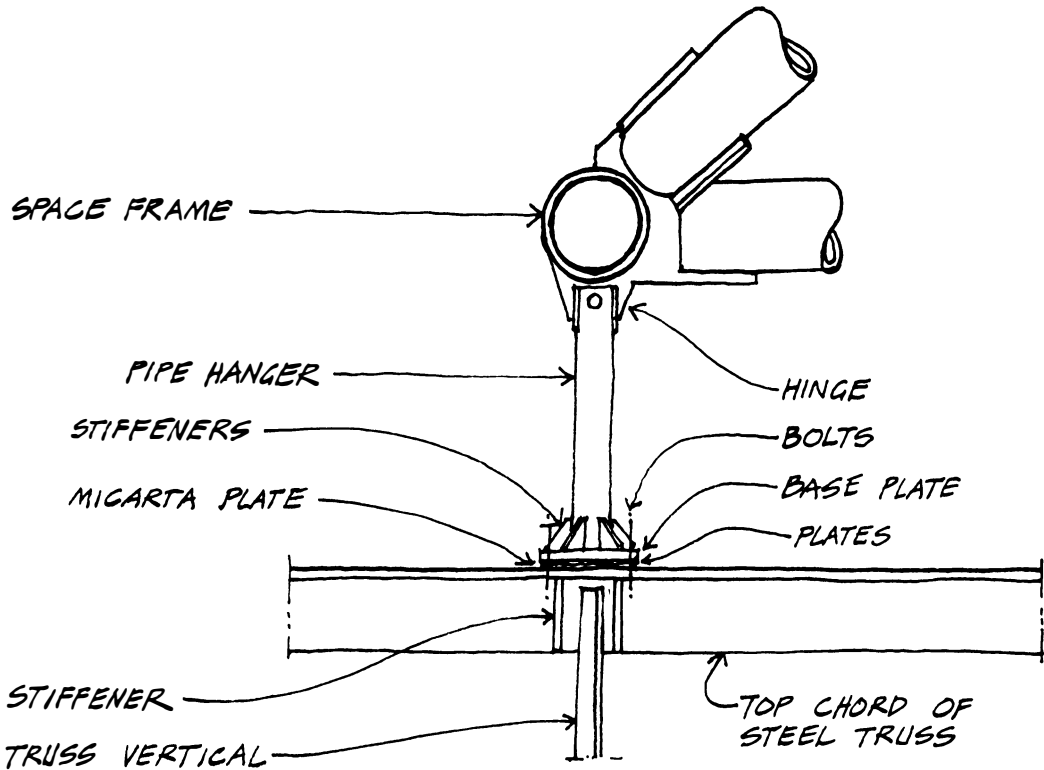
#### 4.6 Components of the Hanger Assembly

The hanger assembly, because of its two essential functions, does not consist of a simple rod as the word "hanger" may have implied to the reader (Fig. 4.6). Since the weight of the roof itself is 26 psf (1.3 kN/m<sup>2</sup>), or about 1,500 tons, and since the roof was designed to carry 25 psf (1.25 kN/m<sup>2</sup>) of additional load caused by rain, the load of the mechanical systems, and other hanging loads (or about

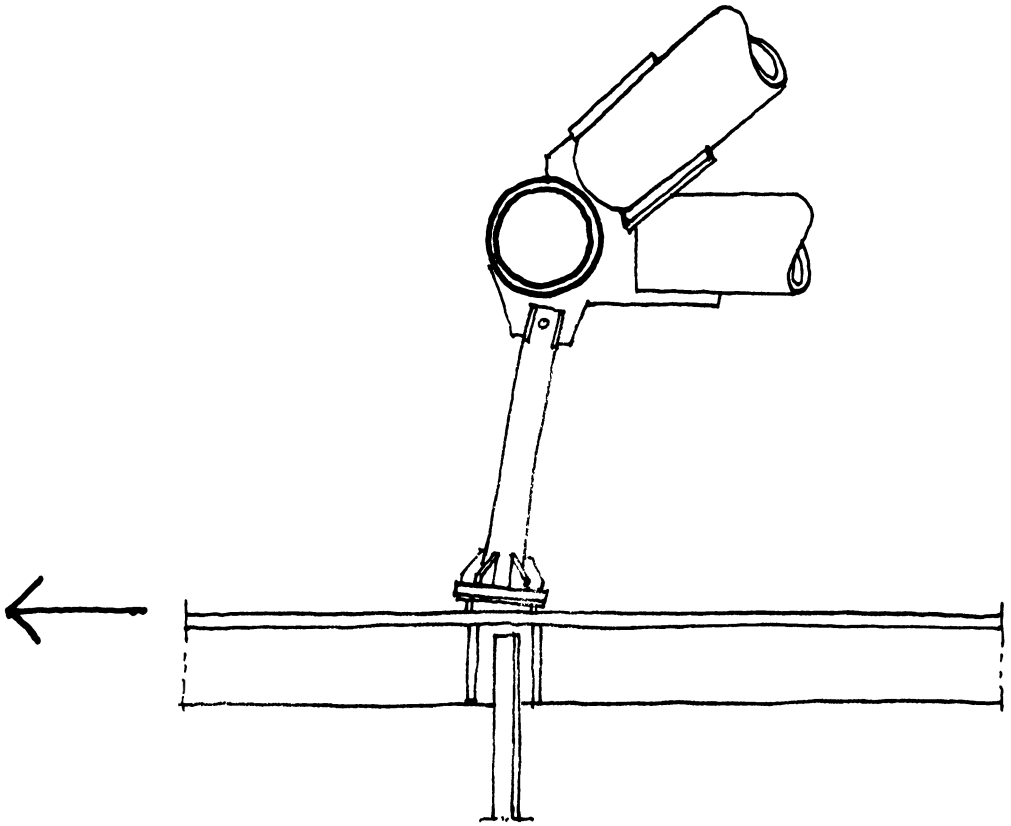
#### 4.7 Hanger Assembly: bent by Lateral Force

another 1,500 tons), then each of the forty-two hangers was to support in *tension* 140,000 lb. (622 kN). Moreover, they had to resist the horizontal, variable wind forces (exerted on the roof and on the upper part of the walls hanging from it), which tended to move the roof horizontally as a gigantic pendulum. For this purpose six of the hangers were hinged both at their top and about halfway down their length, while the remaining thirty-six were hinged only at the top and connected (almost) rigidly to the top chord of the large trusses. While the two-hinge hangers allowed the roof to move as a pendulum, the single-hinge hangers limited the horizontal roof motions to the *bending* deflections of these hangers (Fig. 4.7).

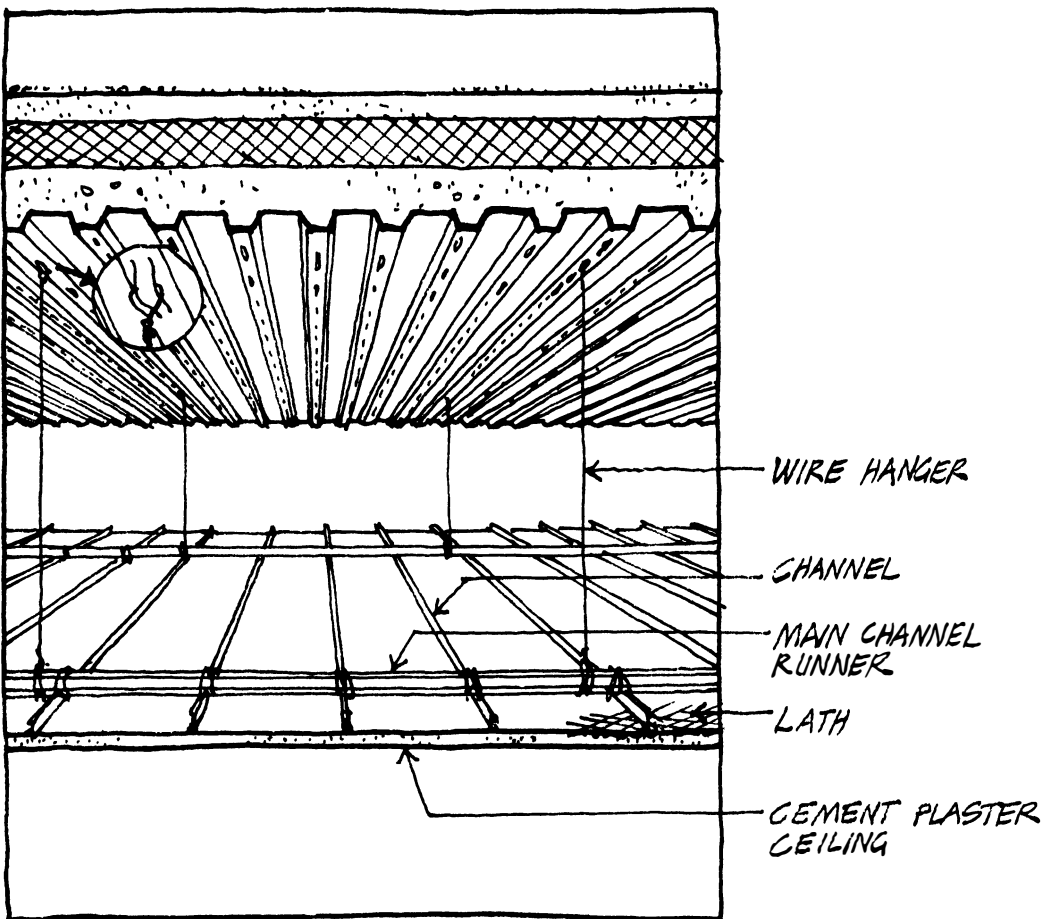
4.9 Components of the PATH Railroad Station Ceiling

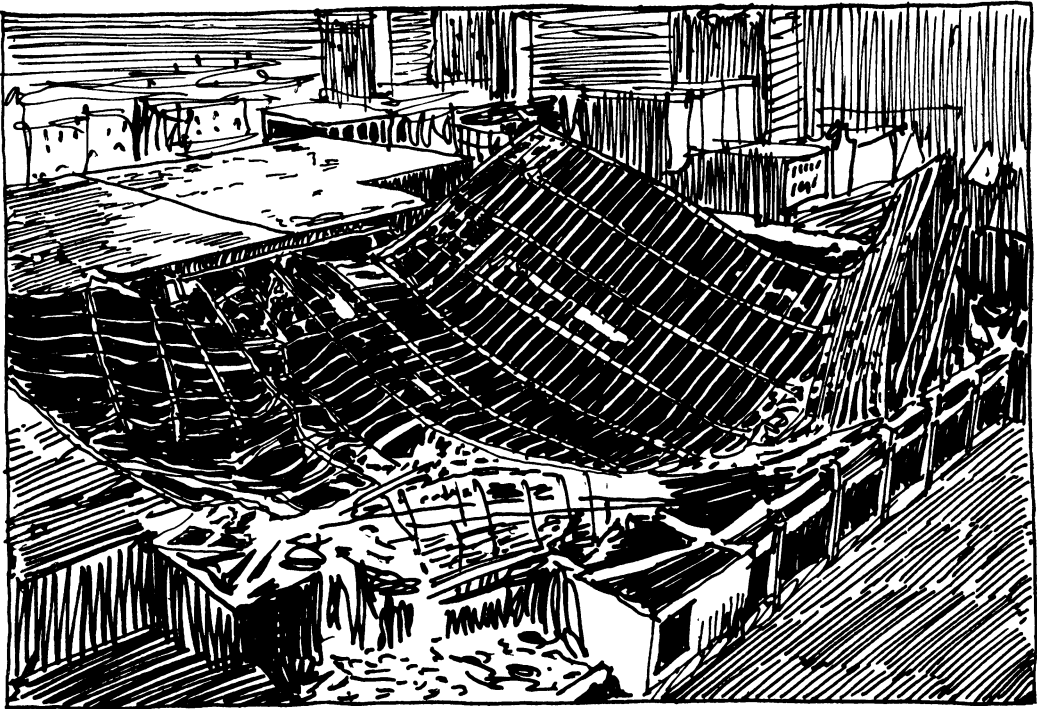
4.10 Hartford Center Roof: after the Collapse

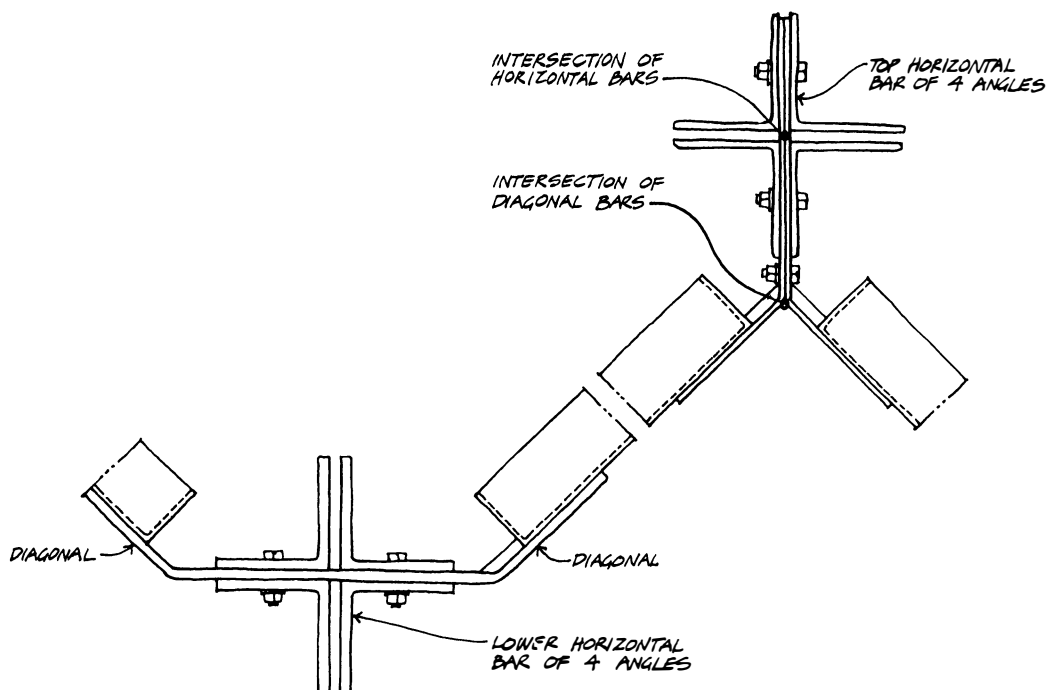
**4.13 Diagonals Eccentrically Connected to Cross-Shaped Chords**

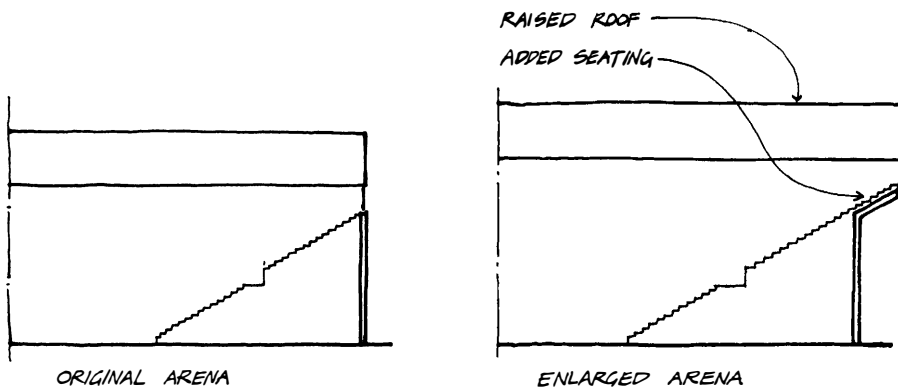
4.15 Section through Original and Enlarged Arena

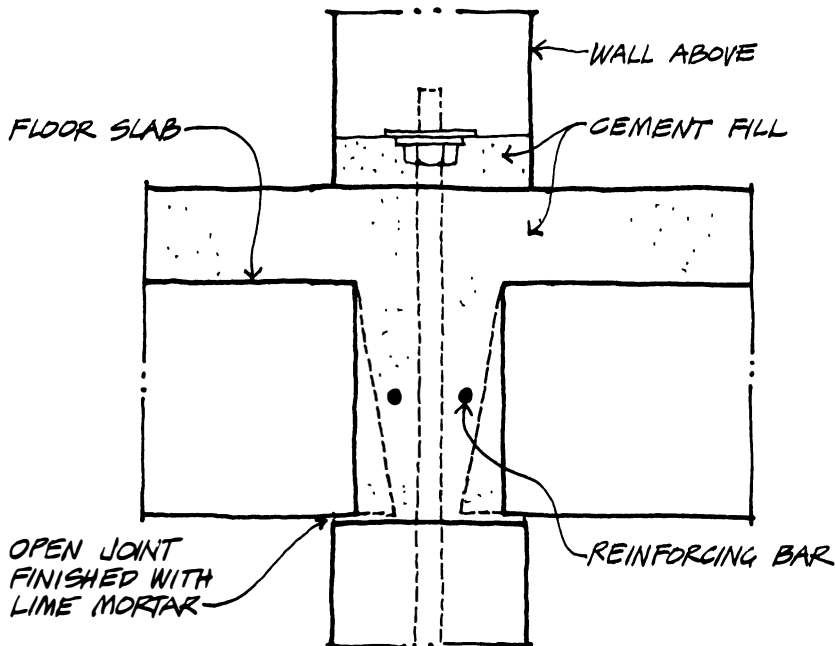
### 5.3 Joint between Interior Wall and Floor Slabs

push a wall panel off the floor. Since the explosion in Miss Hodge's apartment did not damage her eardrums, it was deemed to have caused a pressure against the wall panels of less than 10 psi (0.07 N/mm<sup>2</sup>). Yet tests showed that this pressure, equivalent to that felt when one swims under only 10 ft. (3 m) of water, was high enough to cause the failure of a reinforced concrete wall either by bending it or by overcoming the friction resulting from the gravity loads and kicking it out. Tests conducted by experts from the tribunal established by the government to determine the cause of the collapse showed that the wall panel would slide out against the floor panel at a pressure of 2.8 psi (0.02 N/mm<sup>2</sup>), less than one-third that of the explosion. A witness in a nearby factory reported seeing the wall of Miss Hodge's living room "come out as if pushed sideways and then fall," which is consistent with the fact that the strength of the wall panel in bending was greater than the resistance of the joint in friction. Had the explosion occurred on a lower floor, the loads compressing the wall panels and the resulting friction might have been large enough to have prevented a failure of the wall by sliding.

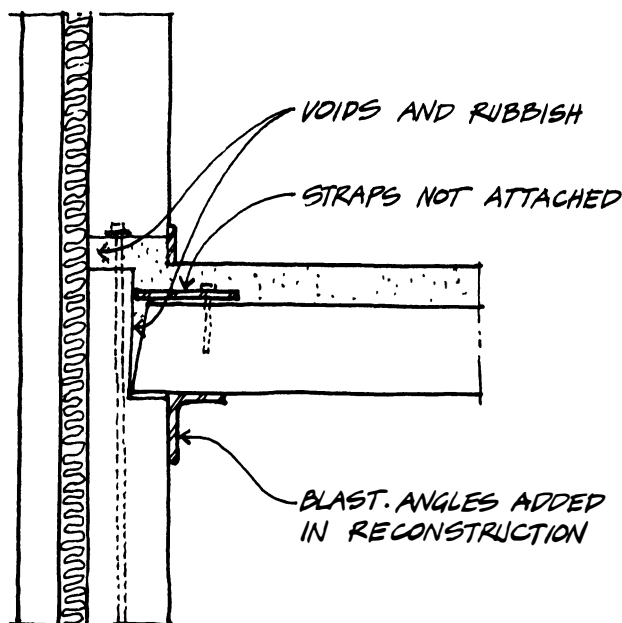
**5.4 Joint between Floor Slab and Outside Wall—Reinforced after the Blast**

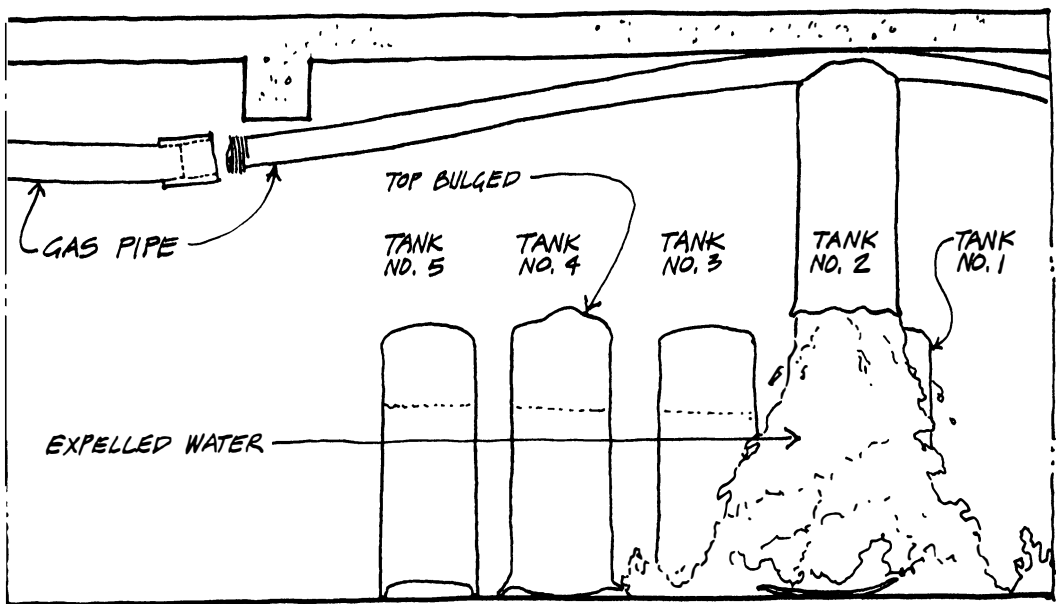
5.6 Ruptured Tank Striking the Gas Pipe

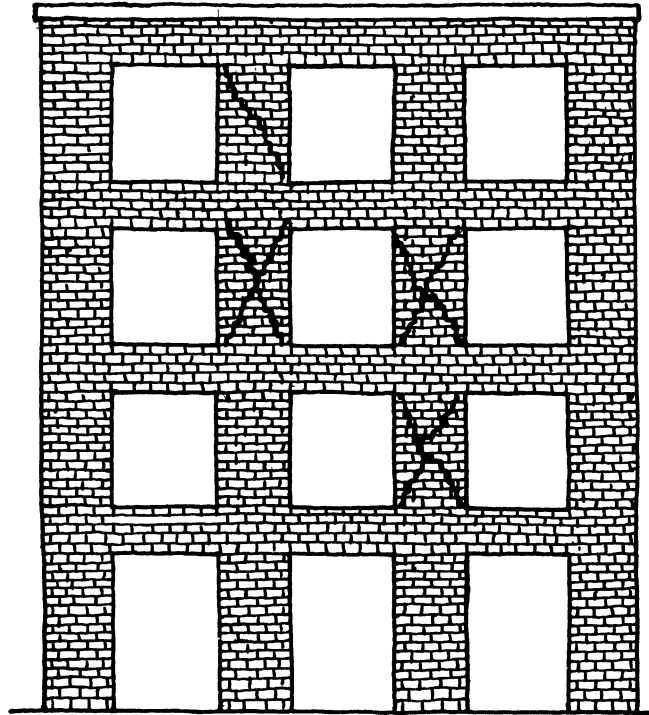
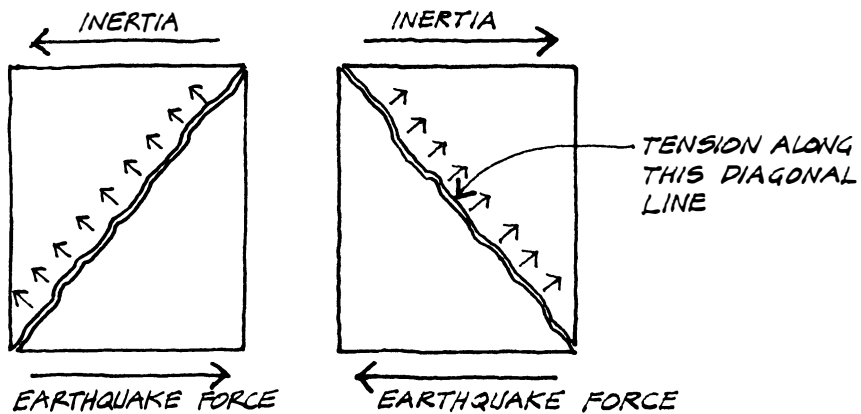
#### 6.4 Diagonal Cracking of Masonry Wall

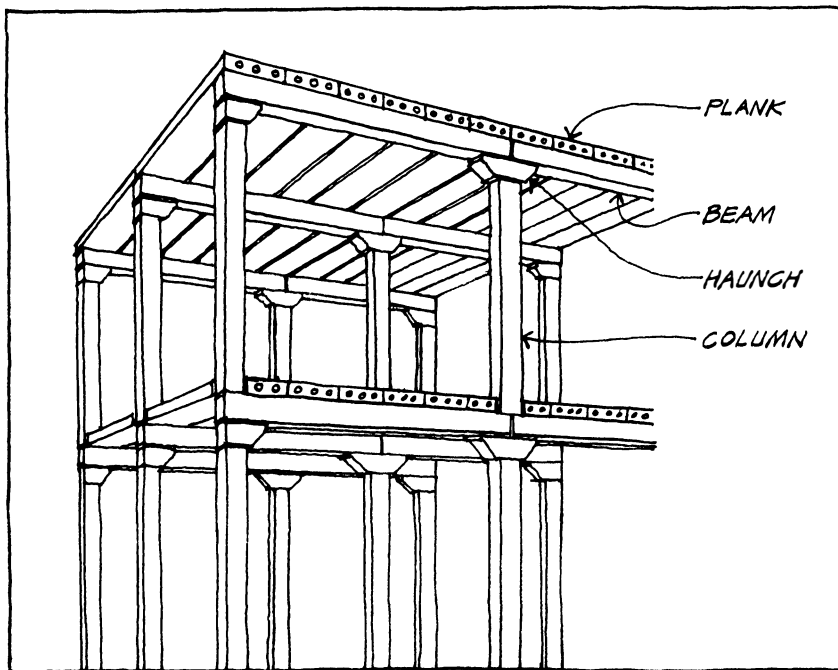
**6.7 Precast Concrete Frame Construction**

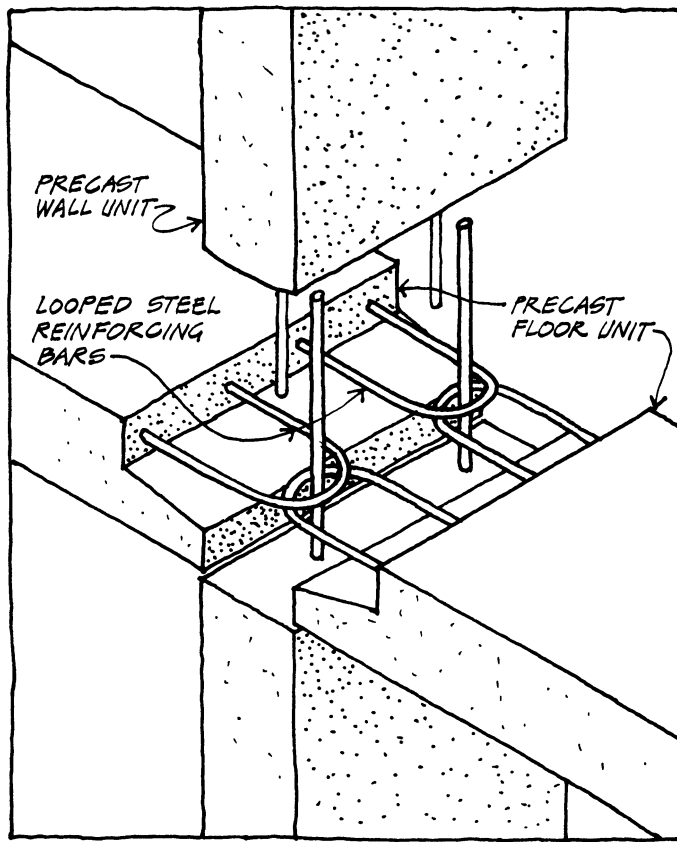
### 6.9 Detail of Joint between Precast Concrete Wall and Floor Panels

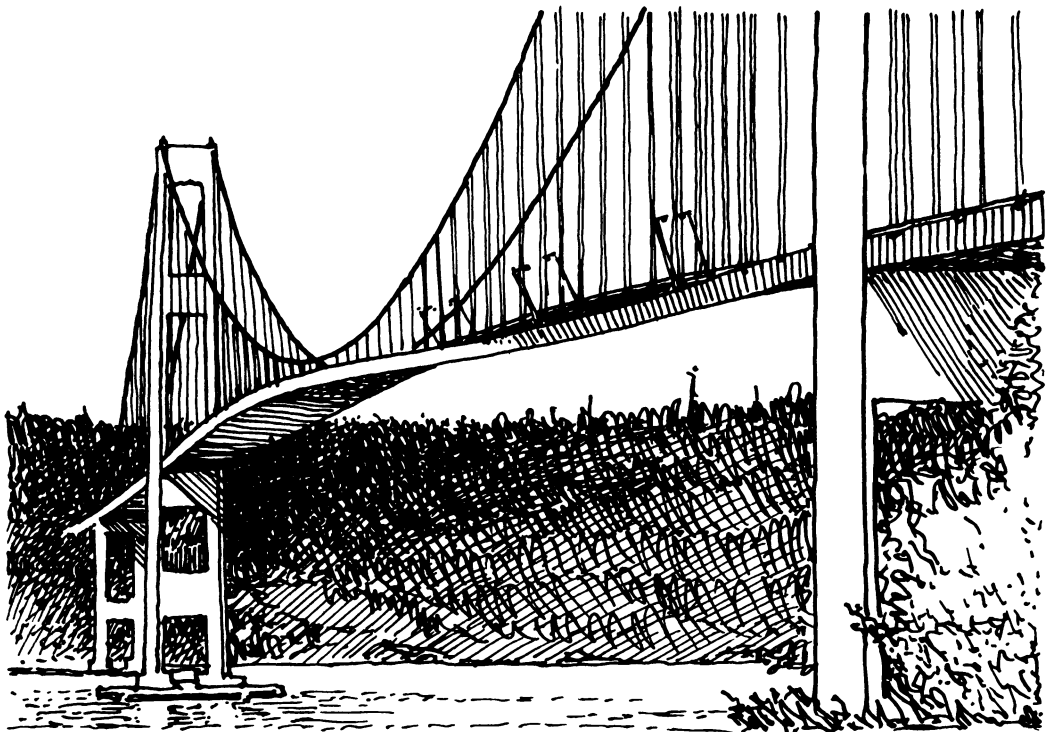
7.3 Twisting Motion of Tacoma Narrows Bridge

circular arc. Shortly before 10:00 A.M. Arkin again checked the wind velocity and saw that it had increased to 42 mph (67 km/h) and that the movement of the bridge deck had heightened dramatically; by his count, the deck rose and fell at the center of the bridge 38 times per minute with a 3 ft. (0.9 m) amplitude. Greatly concerned, Arkin halted all traffic, and Professor Farquharson, who happened to be at the site that day, observed that the up-and-down motion of the center span consisted of at least nine vertical undulations while the bridge was also deflecting laterally by as much as 2 ft. (60 cm). Suddenly the bridge started twisting violently, and the nine-wave motion changed to a two-wave motion while the bridge deck near the Tacoma side appeared to twist to an almost  $45^\circ$  angle (Fig. 7.3).

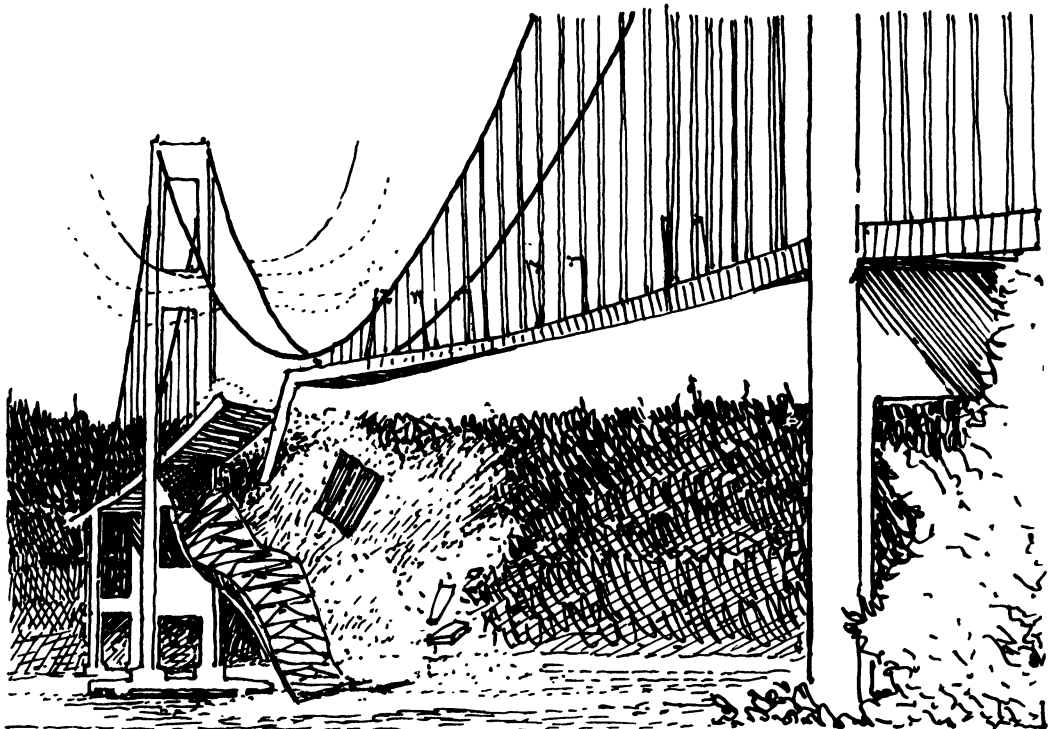
7.4 Tacoma Narrows Bridge at the Moment of Collapse

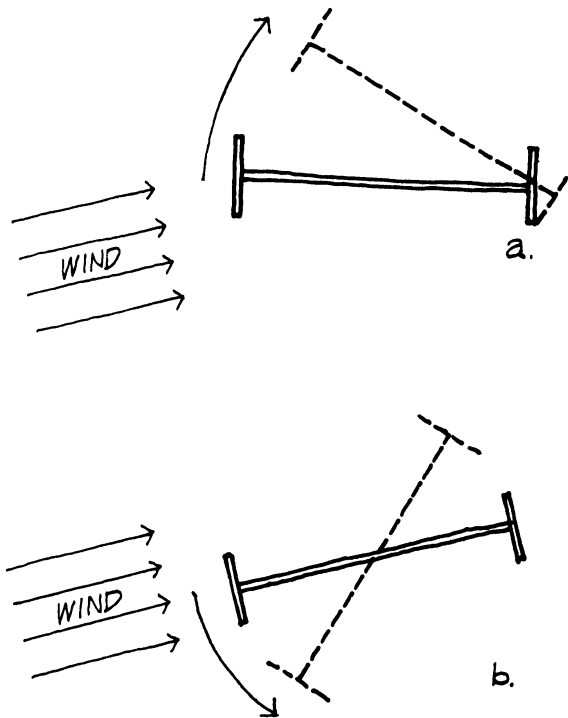
### 7.6 Wind-Induced Twist

\* Recent (1991) studies suggest that the cause may be attributable to vortex shedding, a phenomenon first described by Theodor von Karman. Spiraling vortices can be seen in the wake of a ship moving through water, and similar, though invisible, vortices trail an airplane wing in flight. Two kinds of vortices were shed by the twisting Tacoma Narrows deck. The first is called a Karman vortex street because the periodic shedding creates a continuous pattern of alternating vortices. However, these vortices were out of sync with the natural frequency of the bridge and therefore could not contribute to a buildup of motion. The second was a flutterlike complex pattern of vortices with a frequency coincident with the bridge’s natural frequency that rapidly reinforced the destructive torsional oscillations. It is difficult to state whether the twisting oscillations of the deck caused these vortices or whether the vortices caused the deck oscillations, but at the present time this new assumption must be considered the best interpretation of the cause of the collapse.

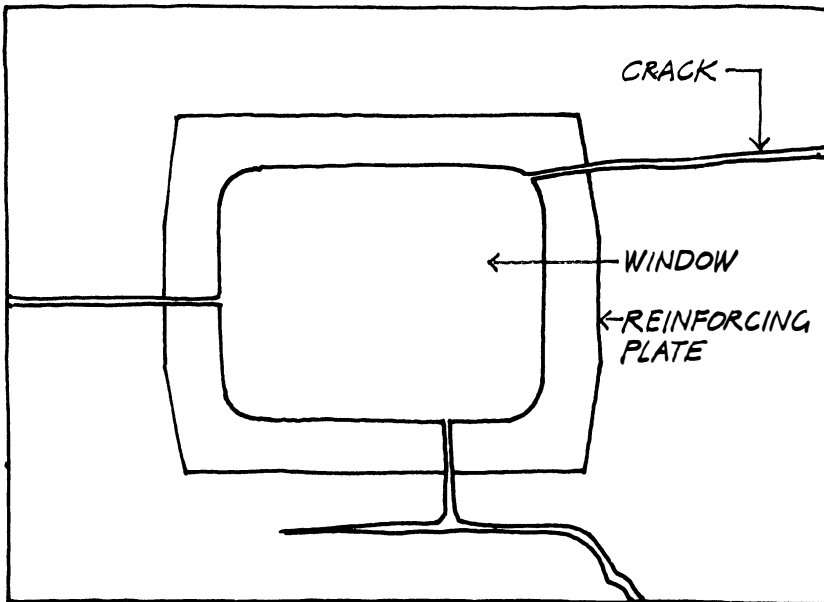
8.1b Cracks around Window

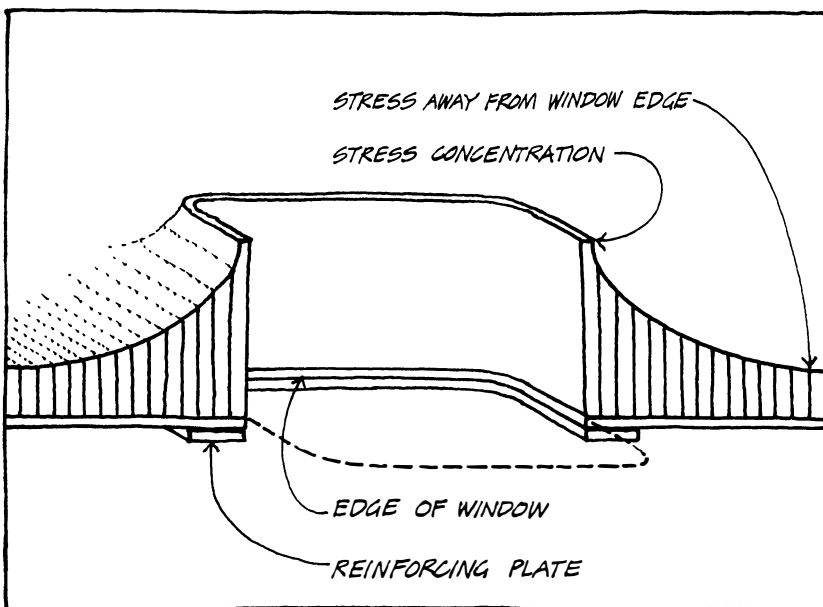
8.2 Stress Concentration at Window's Edge

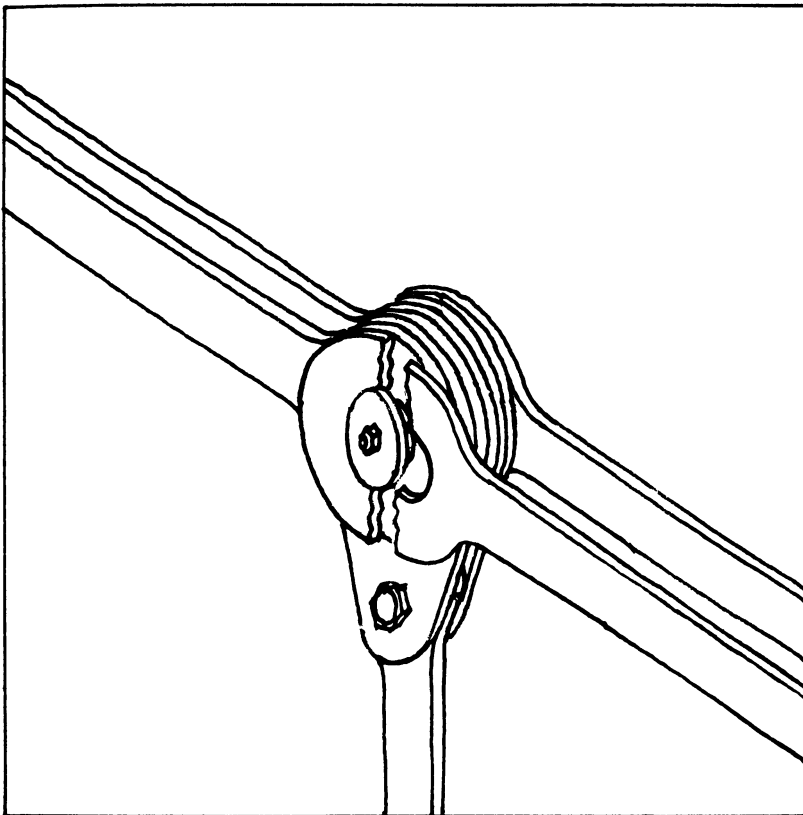
**8.7 Cracked Eyebar**

The need to discover the cause of the Point Pleasant failure led to the decision to salvage and store as many elements of the fallen spans as possible. Fractured, bent, and rusting segments were reassembled into a giant jigsaw puzzle on a 27 acre (10.9 ha) field near the banks of the Ohio. The inquiry panel and its consultants, some of the best bridge engineers and scientists in the country, had the task of locating the bar that broke first. Laboratories were engaged in the conduct of microscopic examinations of the steel in

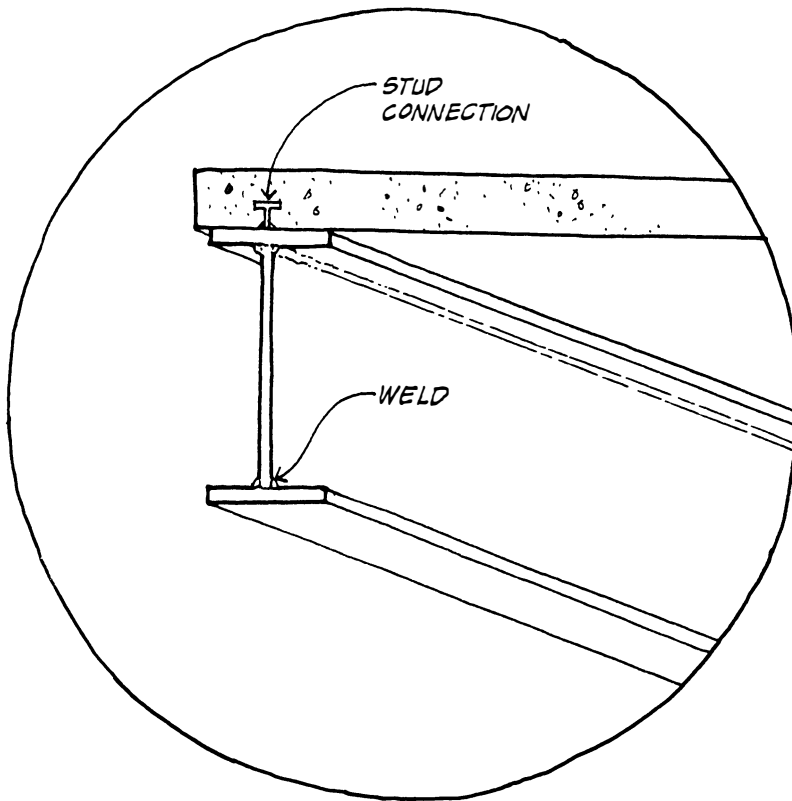
## 9.1 Typical Welded Bridge Girder

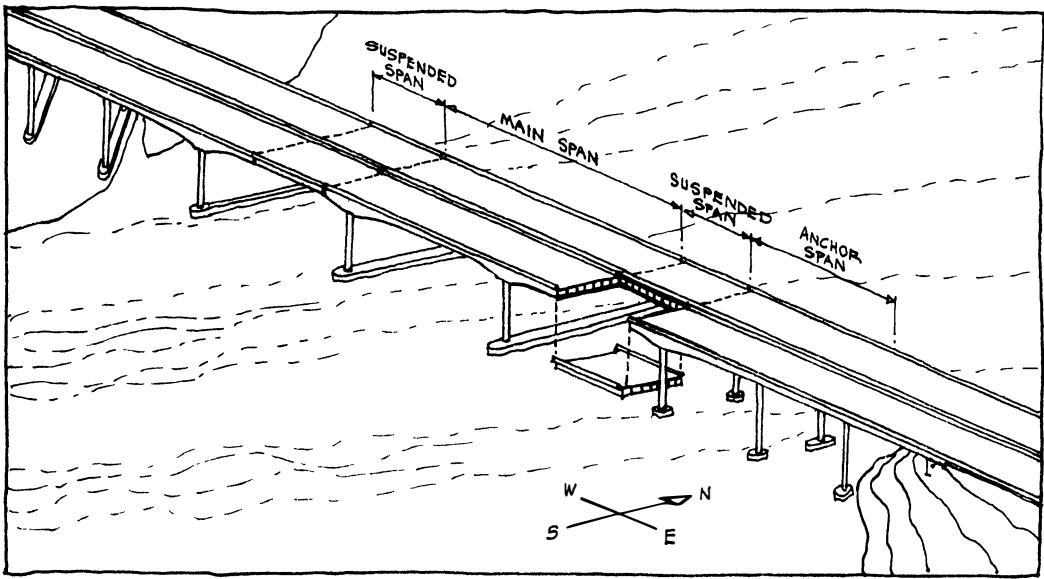
## 9.2 Mianus River Bridge, Showing Collapsed Section

The Mianus River Bridge (Fig. 9.2) is a multiple-span structure carrying more than one hundred thousand cars daily over one of the most highly traveled routes in the world. It consists of two side-by-side three-lane bridges, one carrying westbound and the other eastbound traffic, of cantilevered construction, a type popular in the late 1950s. In cantilevered construction, steel plate girders (large I-shaped beams formed by welding plates together) run over two piers projecting beyond the face of the piers, like arms reaching out, to hold suspended spans. The Mianus bridges had two suspended spans, 100 ft. (30 m) long, on each side of a central span. The east end of the easterly suspended span was hung by means of a pin-and-hanger assembly from the ends of the east cantilever, and its west end sat in a cradle, called a *pillow block*, on a horizontal pin attached to the end of the cantilever from the central span (Fig. 9.3). Each hanger assembly consisted of two vertical steel plates pinned at the top to the cantilevered end of the anchor span and at the bottom to the end of the hung span (Fig. 9.4). Just

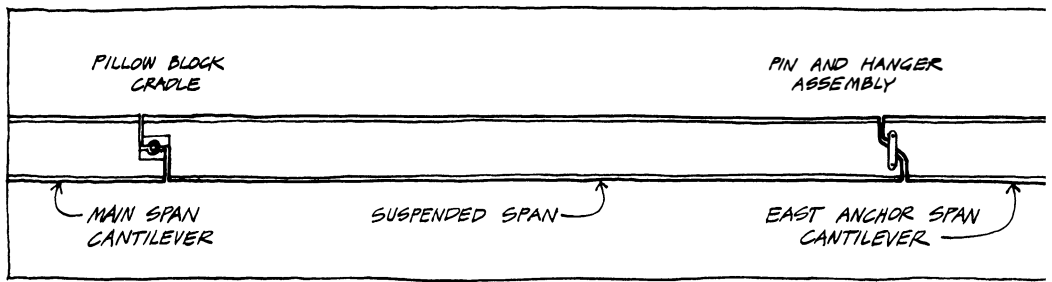
### 9.3 Suspended Span Support Conditions

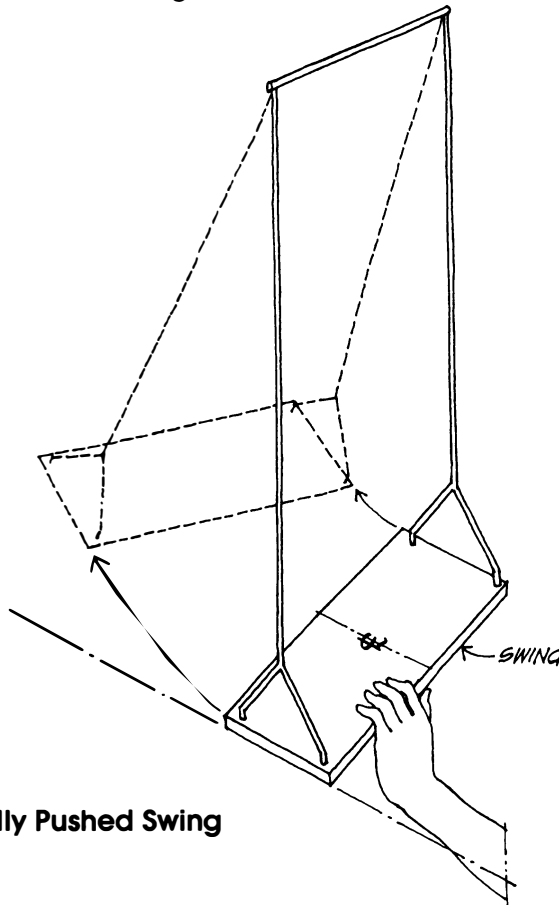
## 9.5 Eccentrically Pushed Swing

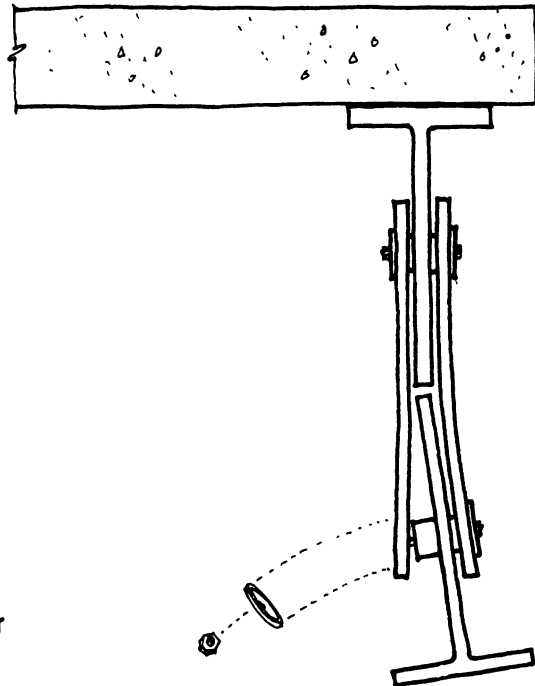
9.6 Failure of Hanger

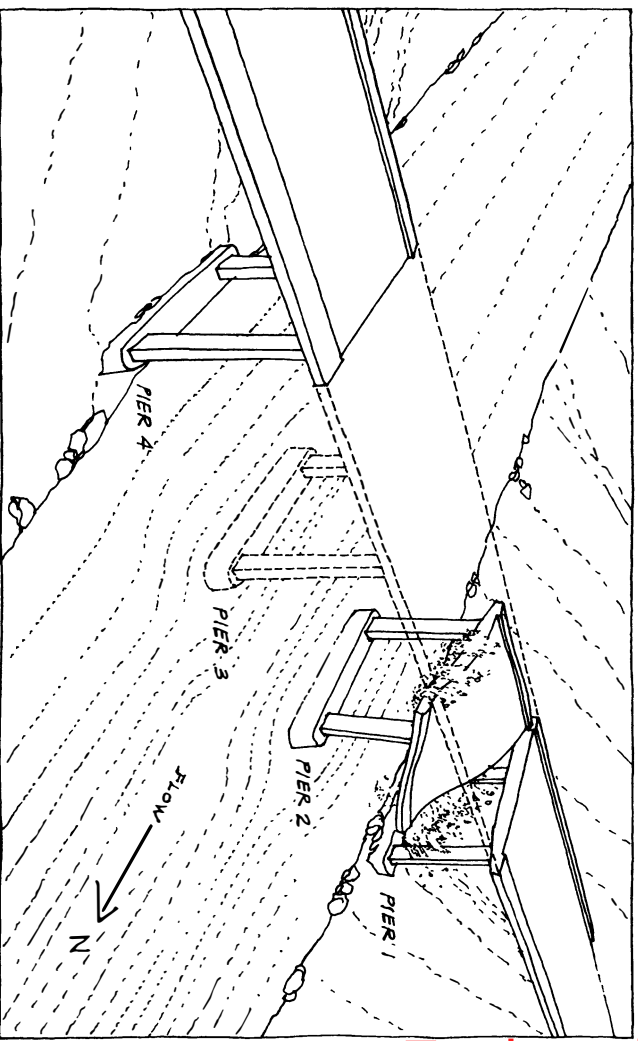
9.9 Collapsed Schoharie Bridge

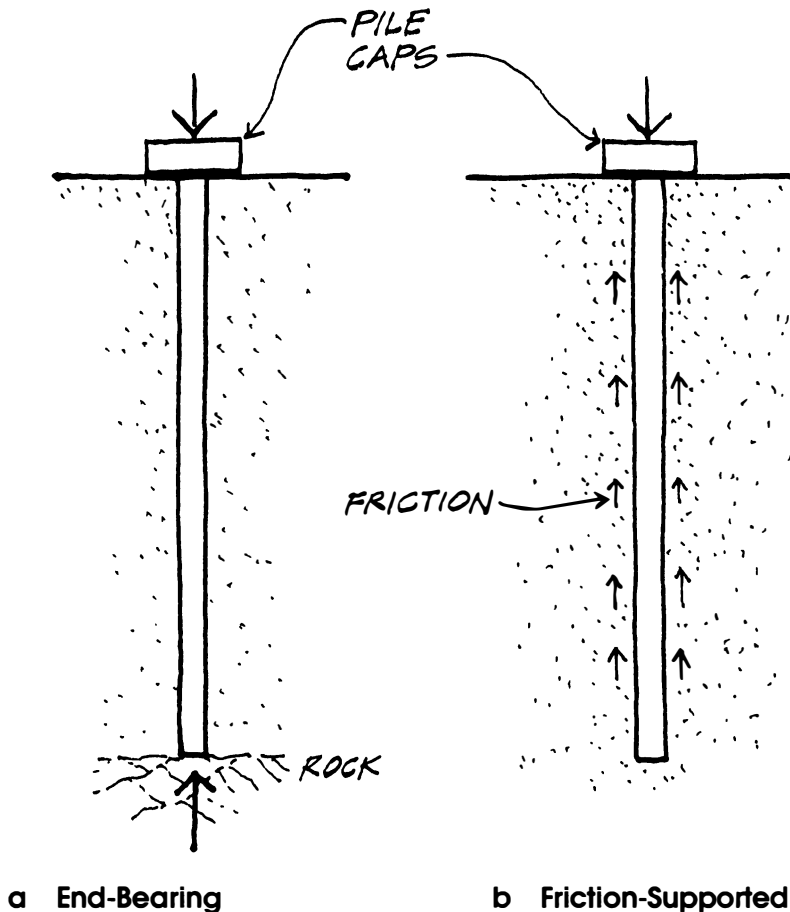
### 10.2 Piles

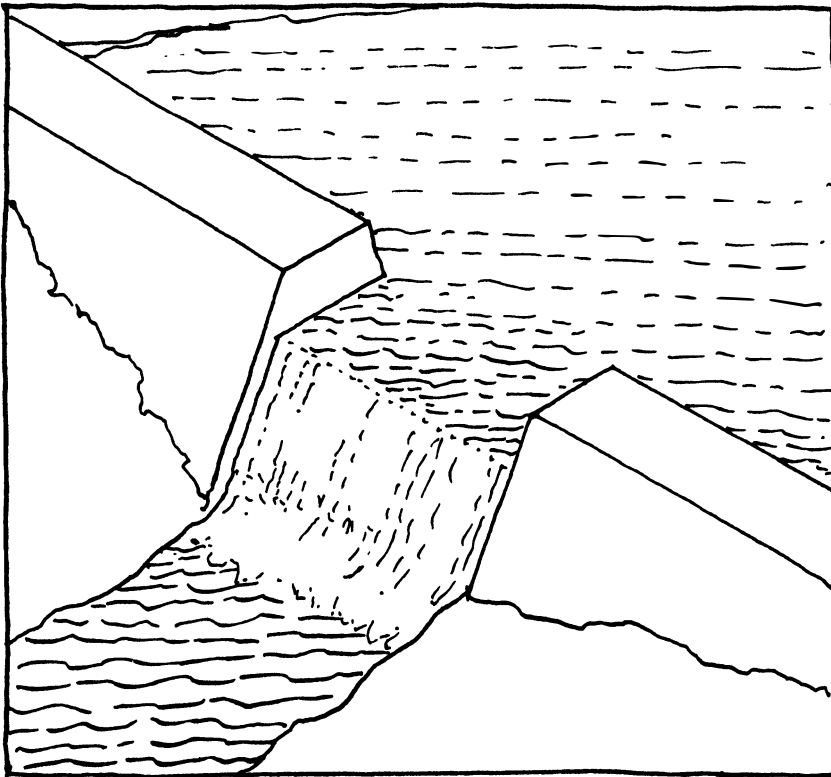
**11.1 South Fork Dam: Original Construction**

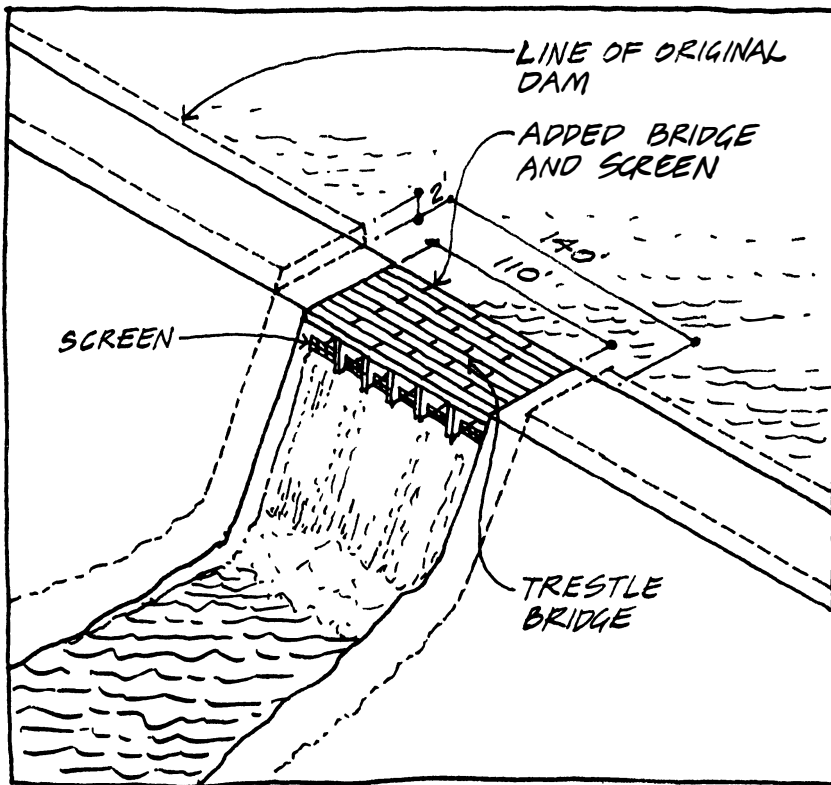
11.2 South Fork: Modified Dam and Spillway
