# WHY BUILDINGS FALL DOWN

How Structures Fail

MATTHYS LEVY  
and  
MARIO SALVADORI

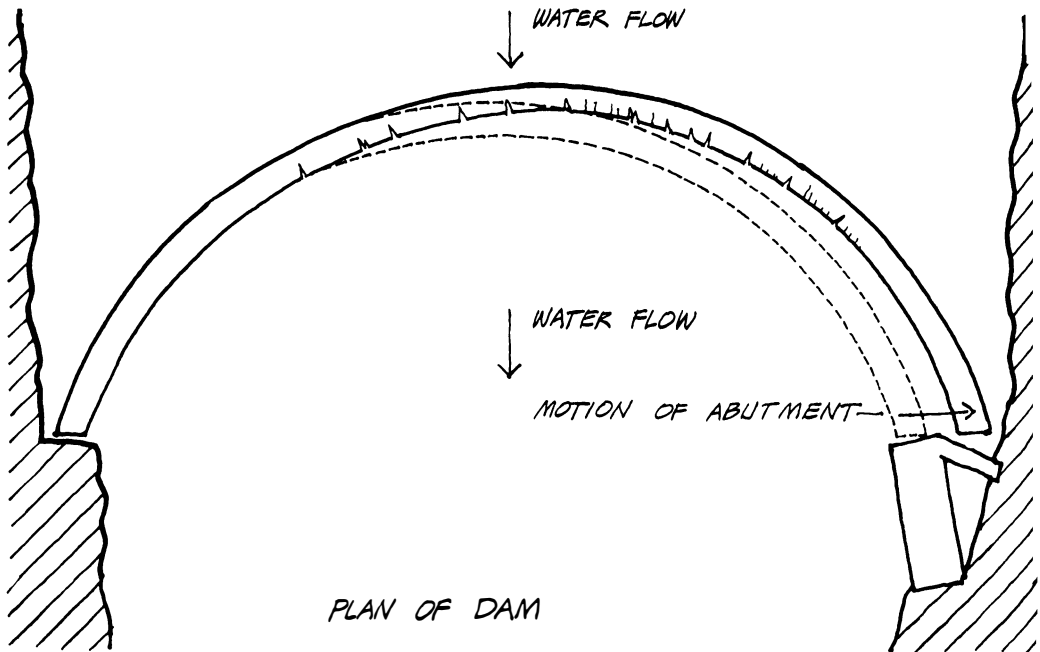
**11.6 Failure of Arch Owing to Displacement of Abutment**

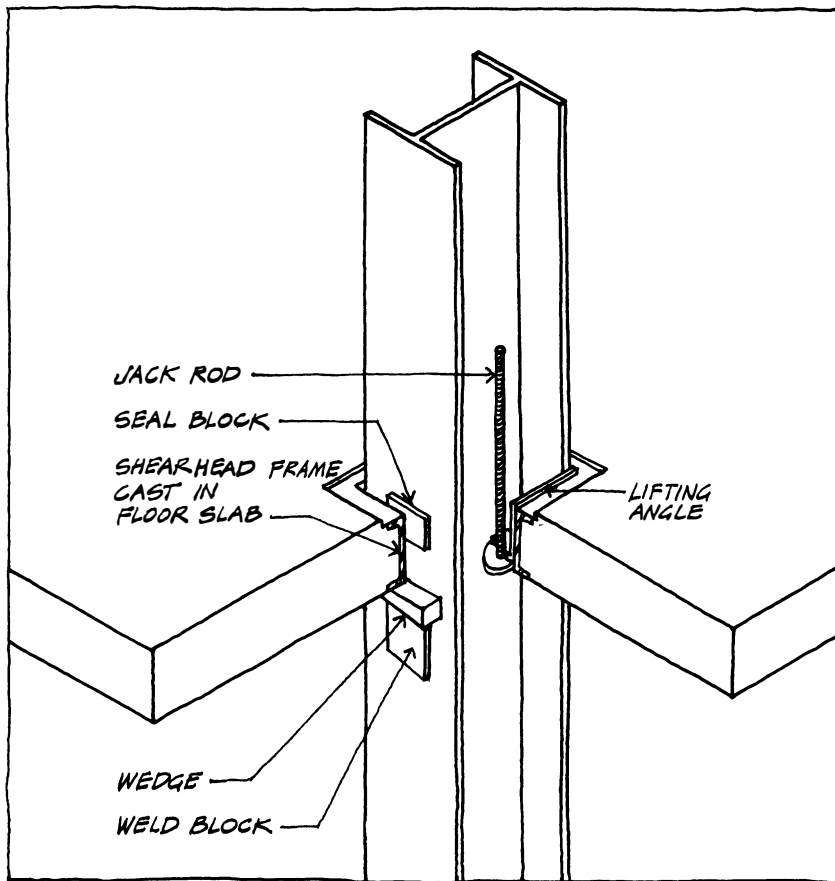
## 12.4 Typical Shearhead Arrangement

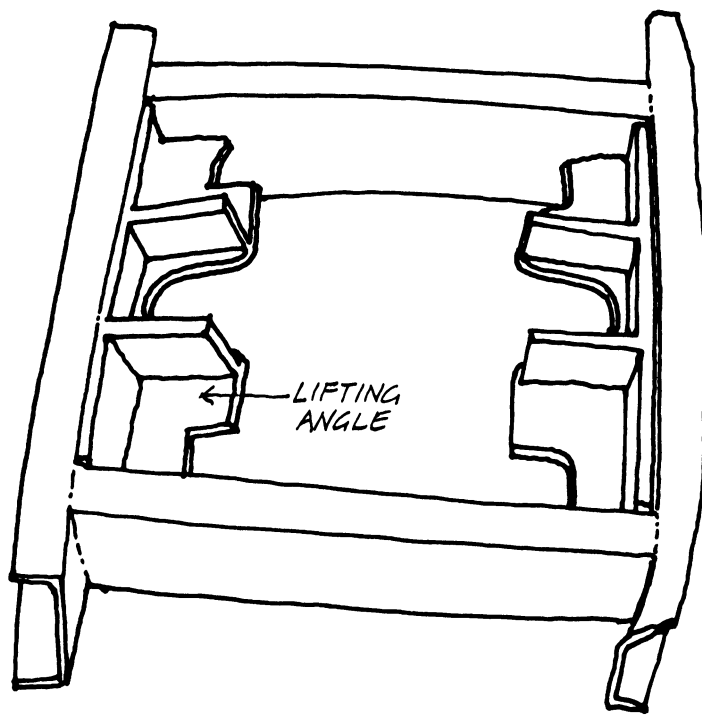
## 12.6 Failed Shearhead Showing Rotation of Lifting Angles

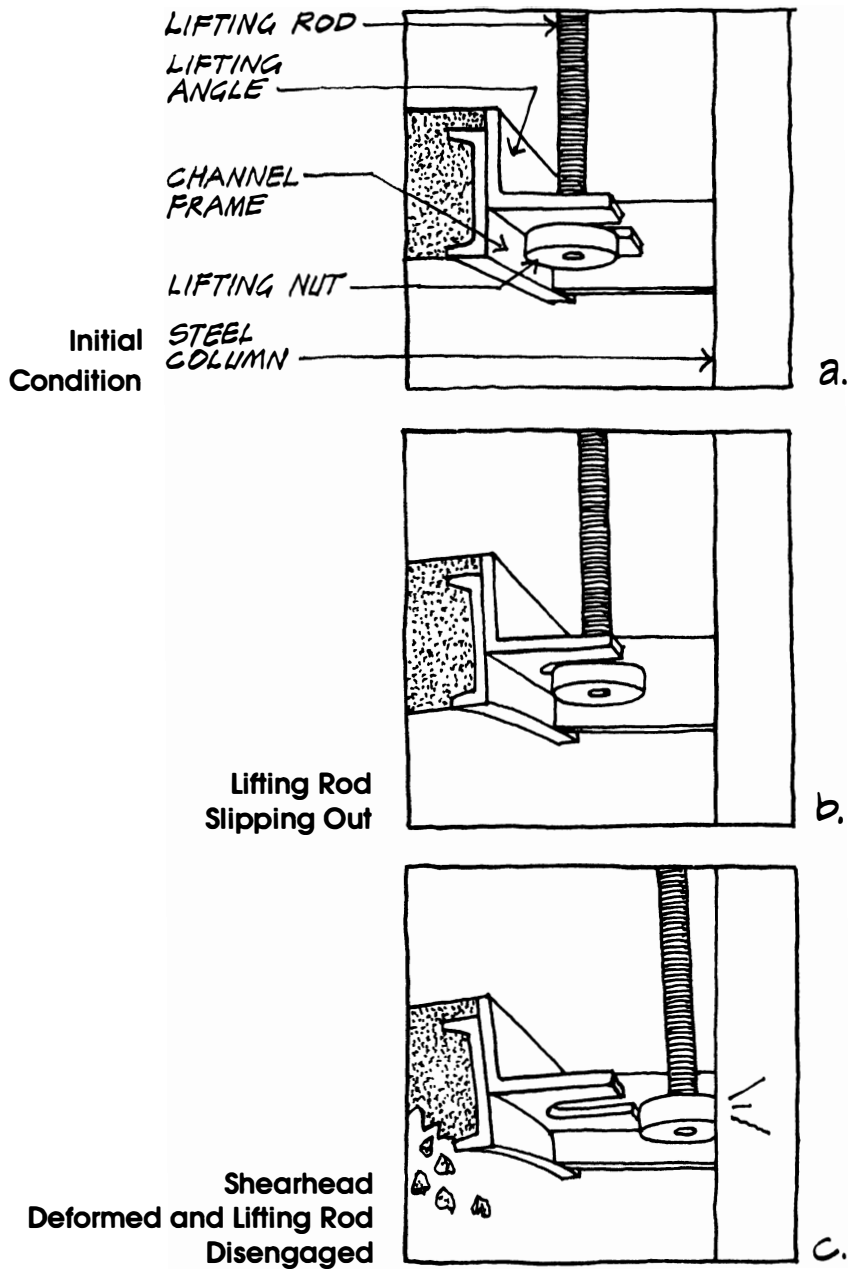
## 12.7 Failure Sequence

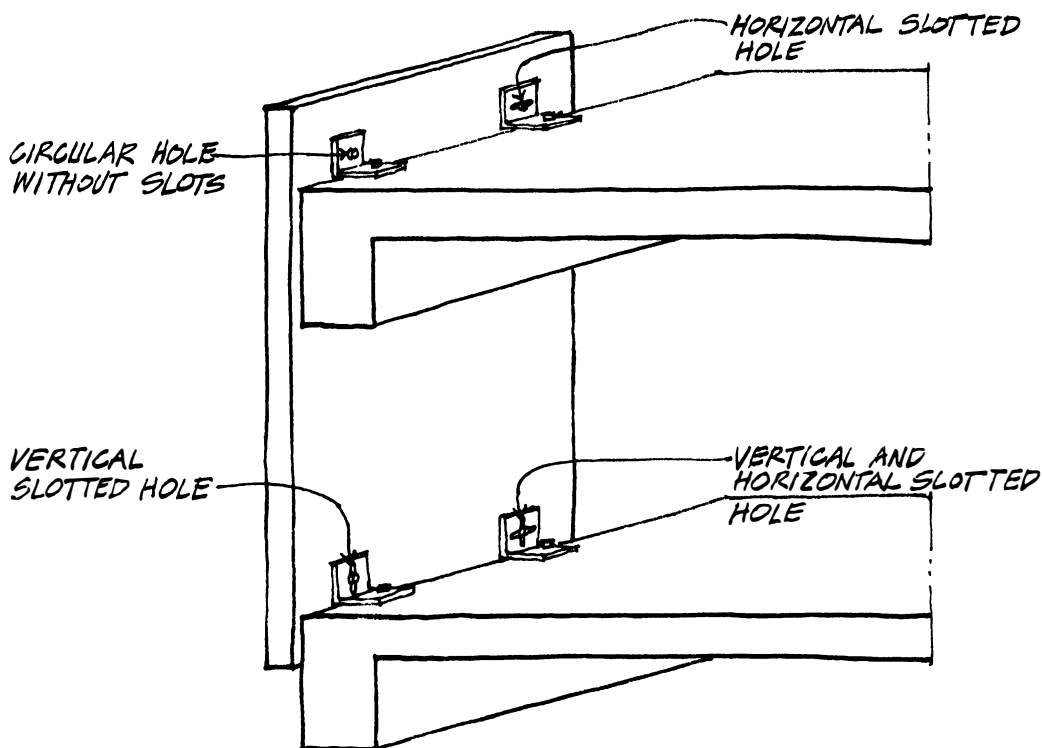
13.1 Attachment of Precast Panel

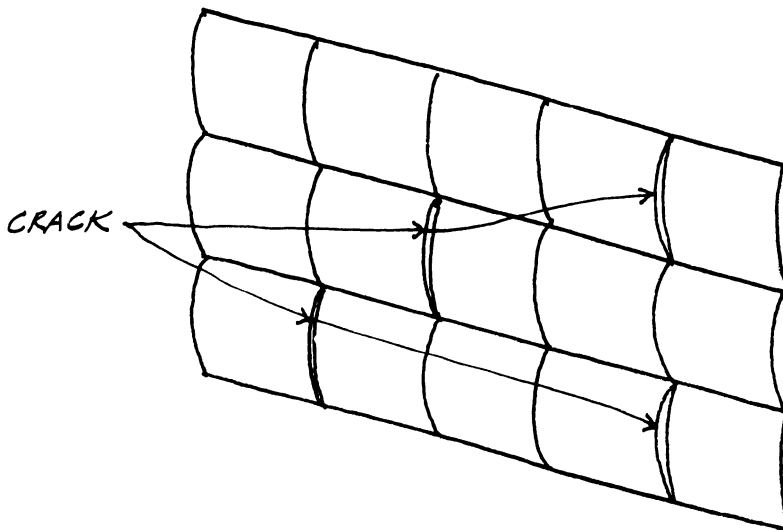
**13.6 Bowed-Out Wall Panels**

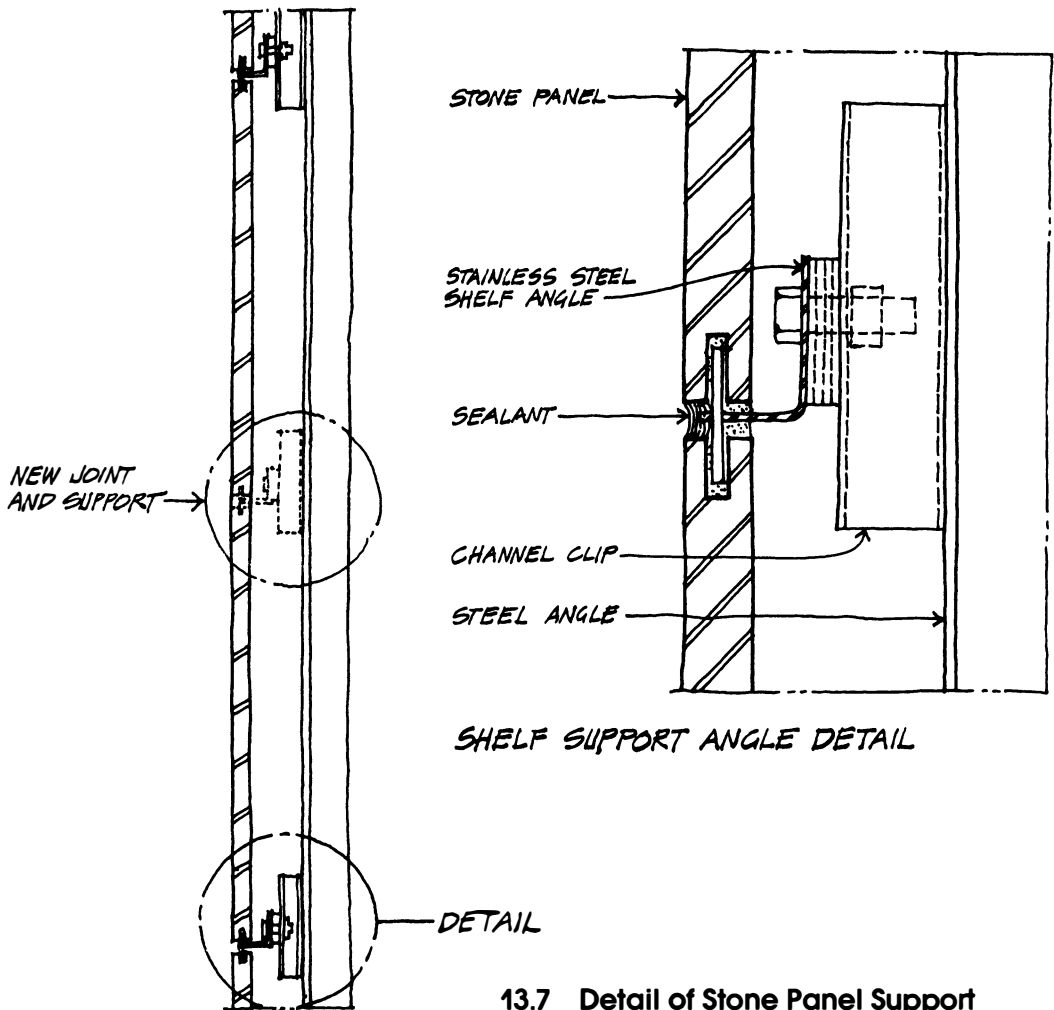
### 13.7 Detail of Stone Panel Support

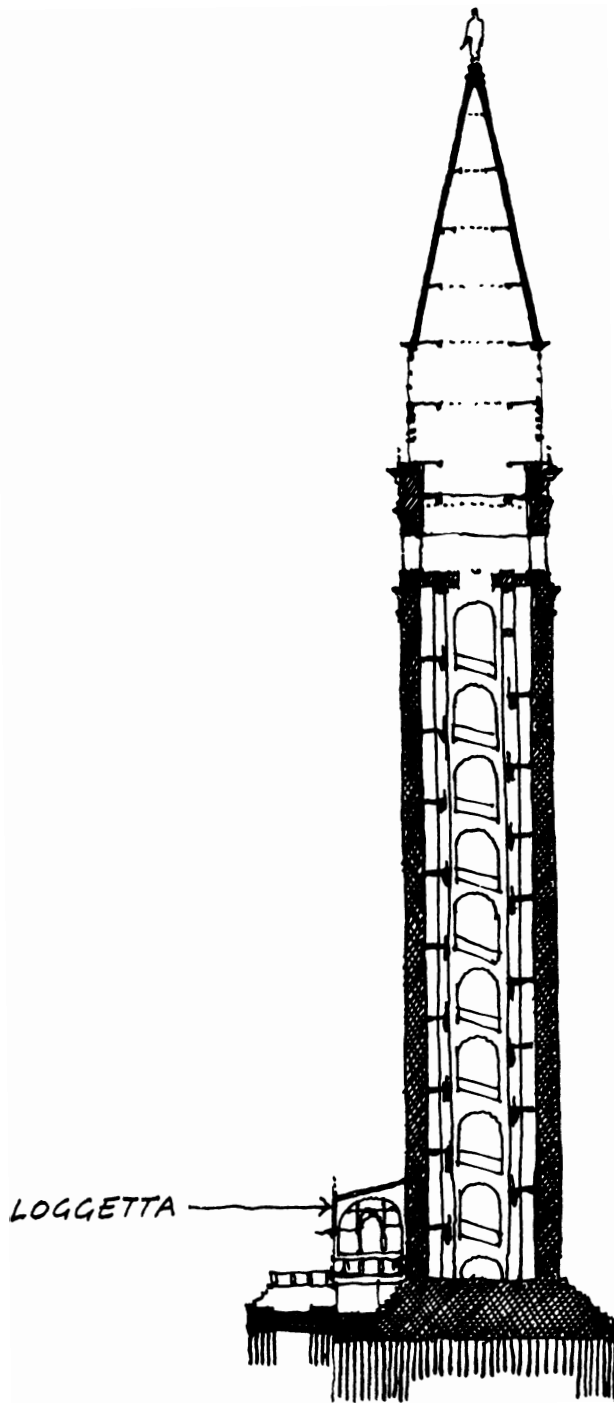
14.2 Section through Campanile of San Marco

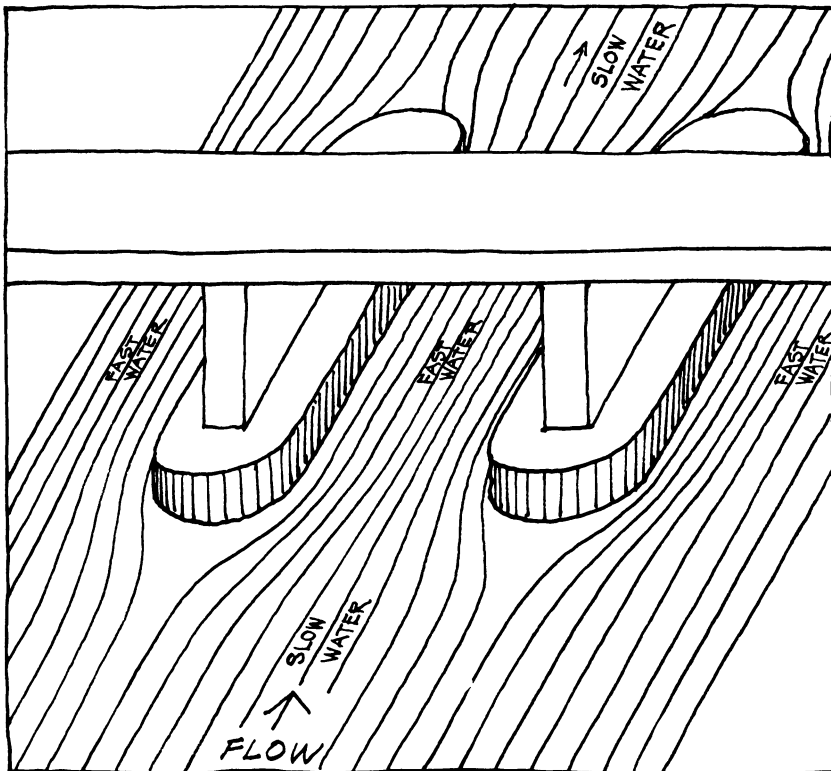
14.5 Flow of Water around Bridge Piers

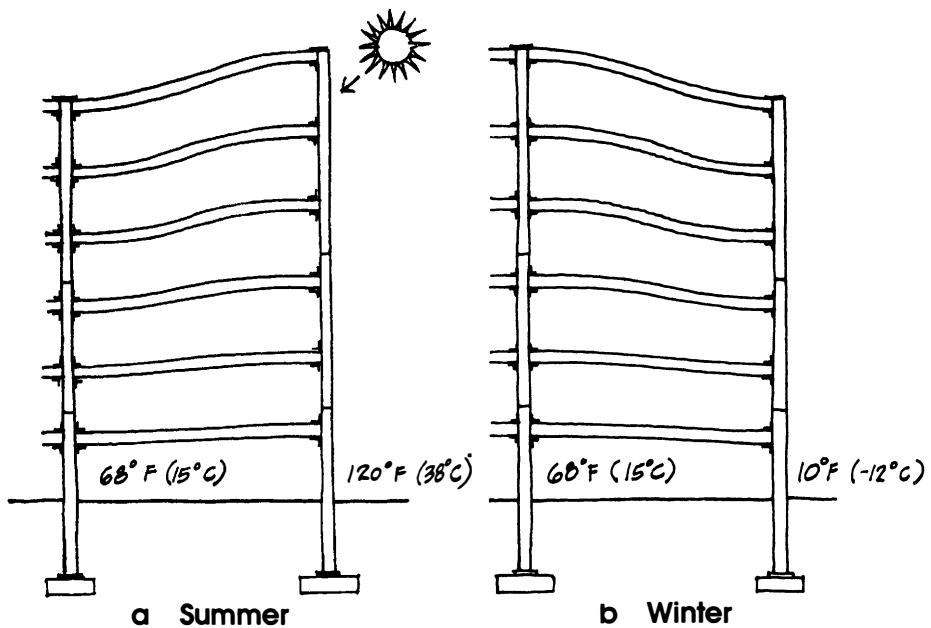
### A3 Thermal Bending of Frame Beams in:

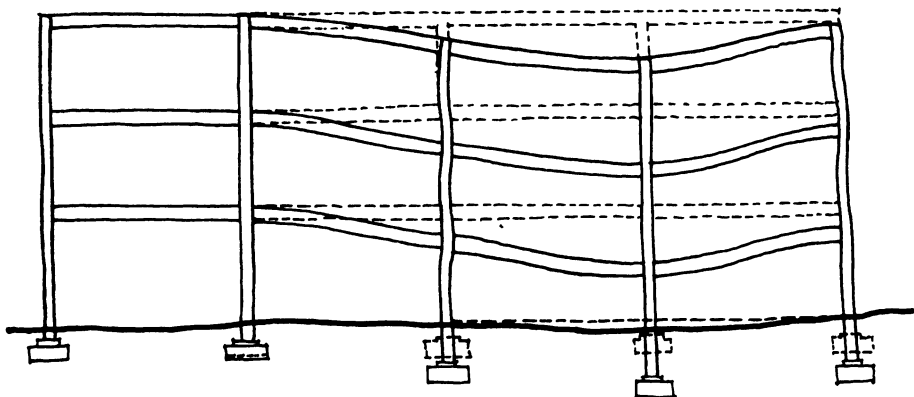
**A4 Uneven Settlement of Building Foundation, Causing Bending of Beams**

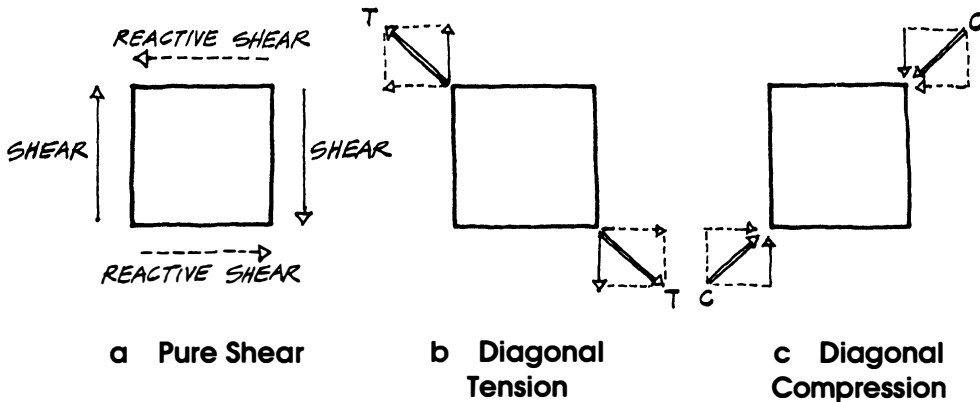
## D12 Shear Equivalent to Tension and Compression

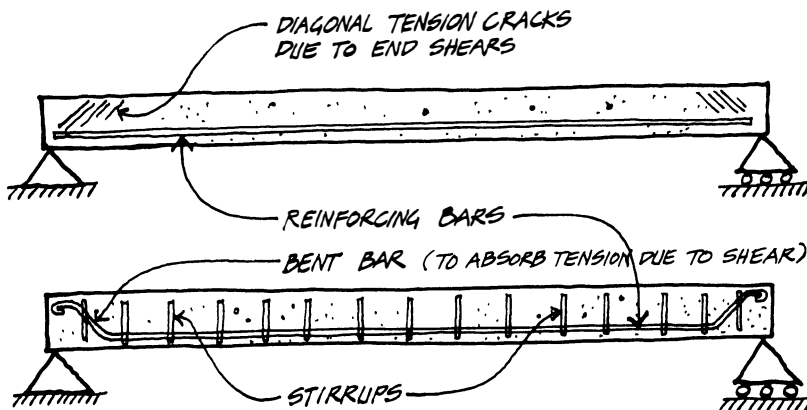
### D13b Reinforcing to Resist Shear in Concrete Beam

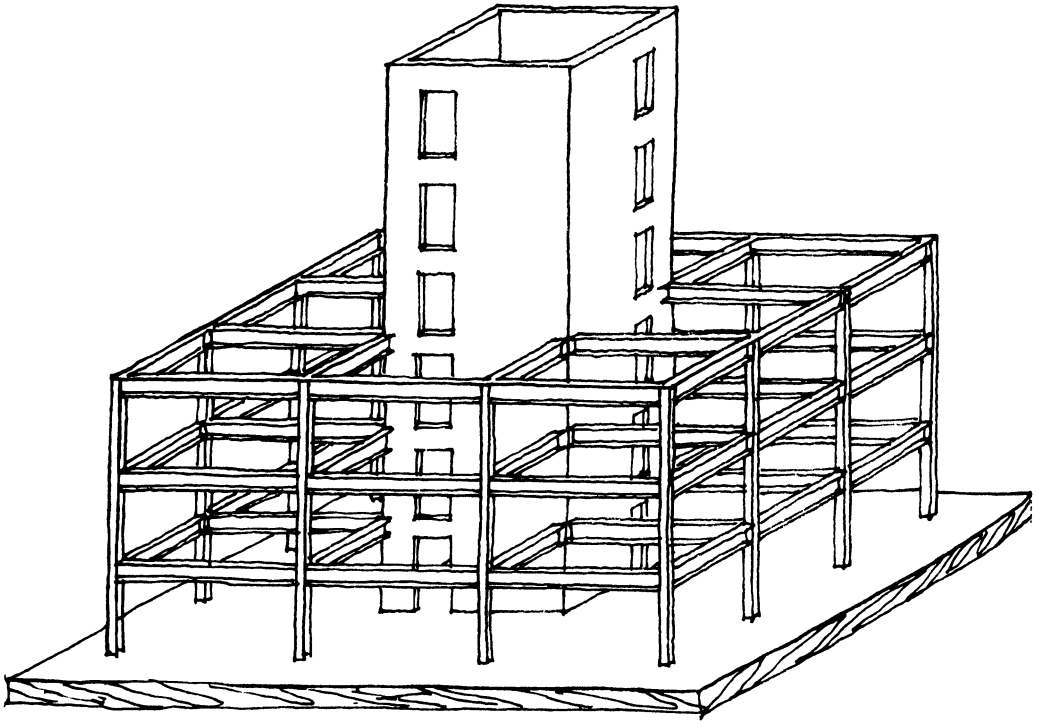
**D24 Steel Frame with Concrete Core**

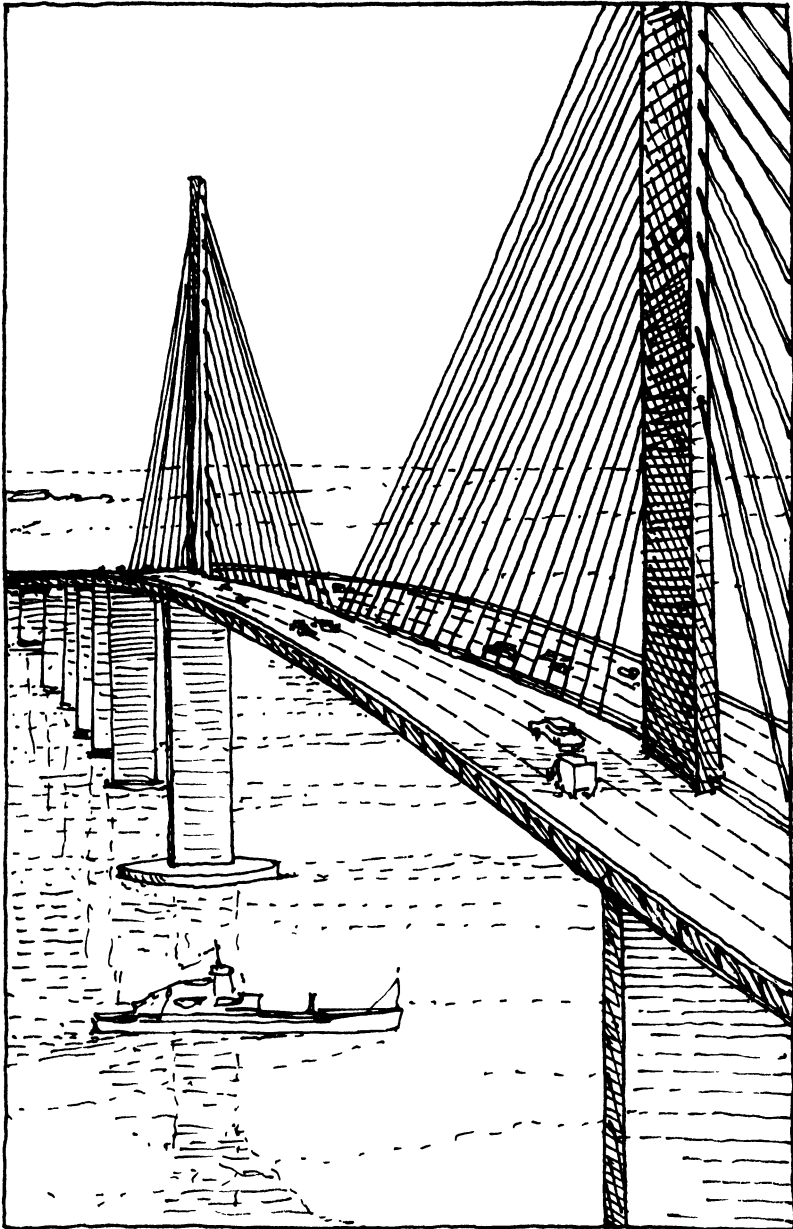
**D37 Cable Stayed Bridge, Sunshine Skyway, South of St. Petersburg, Florida**
